Building Program

WHITINSVILLE SOCIAL LIBRARY

NORTHBRIDGE'S PUBLIC LIBRARY

prepared by
Mary E. Braney
Library Consultant

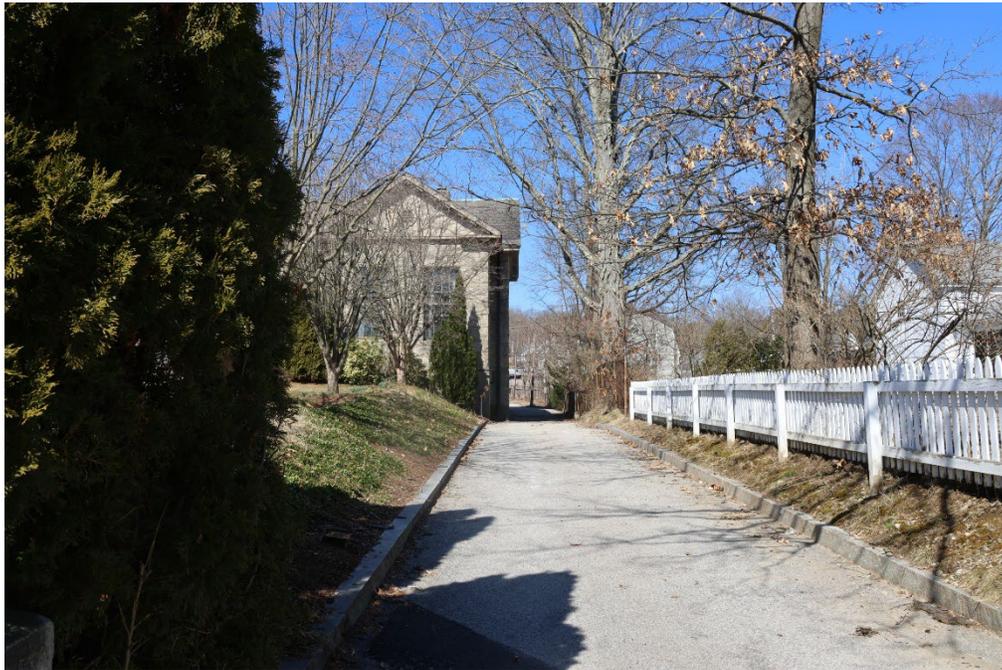
The long, narrow driveway is not easily visible from Church Street and is barely wide enough for a passenger car. It narrows with the jog of the building.

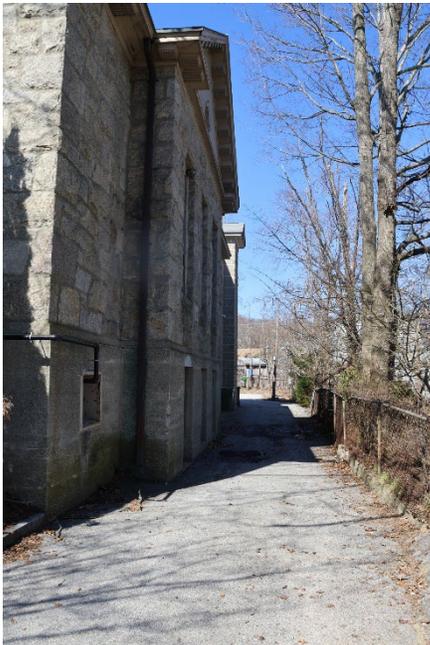
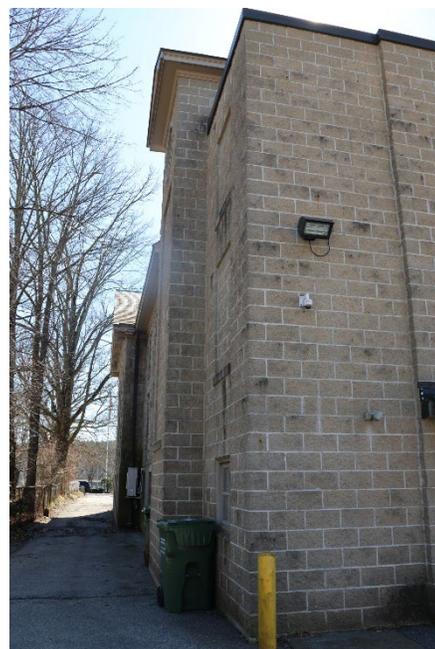
View from Church Street above left; view from rear of library toward Church Street above right.

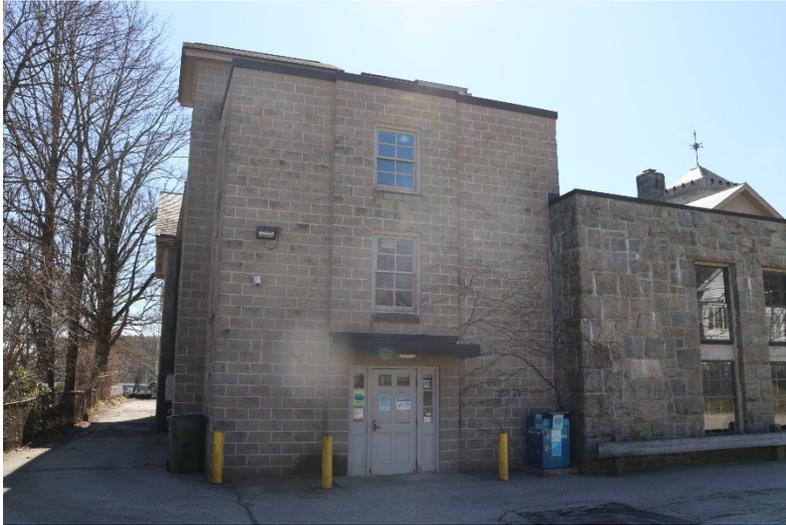
The elevator addition sits at the end of the driveway which opens onto the library parking lot. A sewer line runs under the parking lot.

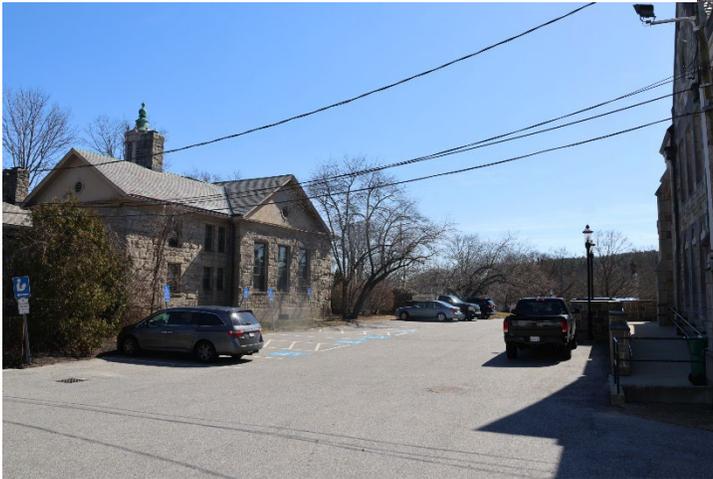
Exterior challenges to providing optimum library services include unevenly paved walkways as seen right in the path from the church parking to the library. Safety cones are placed to mark missing pavers.

- 2025 ADA Exterior Door (Have \$8,000) \$ 12,000.00
- 2025 Repair Walkway \$ 25,000.00
- 2026 Library Exterior Painting \$ 65,000.00
- 2027 Library Interior Painting \$ 65,000.00
- 2028 Library Parking Lot Reclamation/Paving \$ 55,000.00
- 2029 Library Exterior Fencing \$ 68,000.00

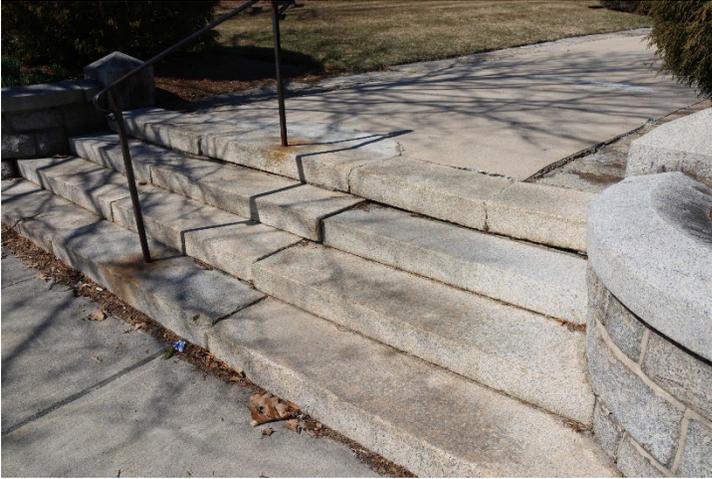
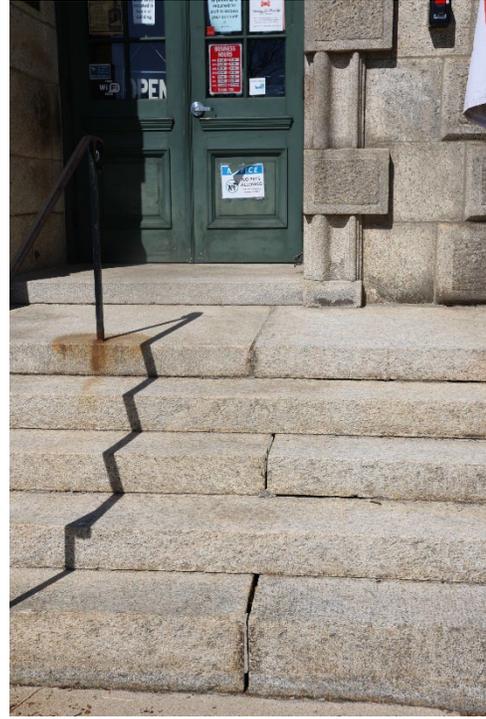
Both the granite stairs leading from Church Street to the entry sidewalk and those leading into the library need repair. The handrails are not ADA compliant, and patrons report that they get too hot to be used in the summer.

- (1) Membrane roof over stacks – leaks are frequent and may interfere with electric service and damage materials
- (2) Stairway and railing systems – patrons have requested action

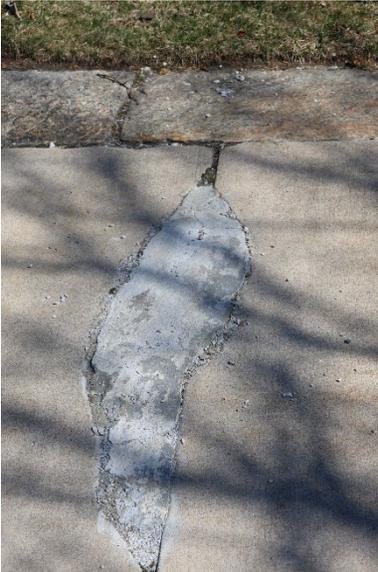
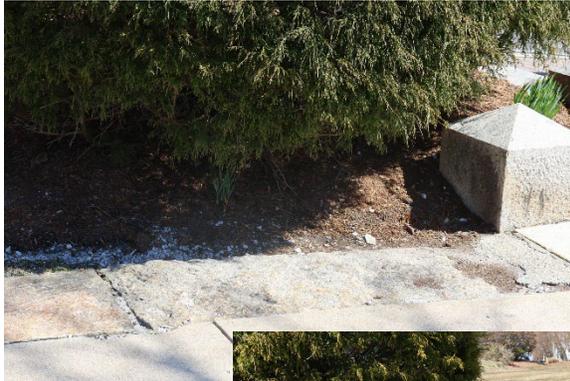
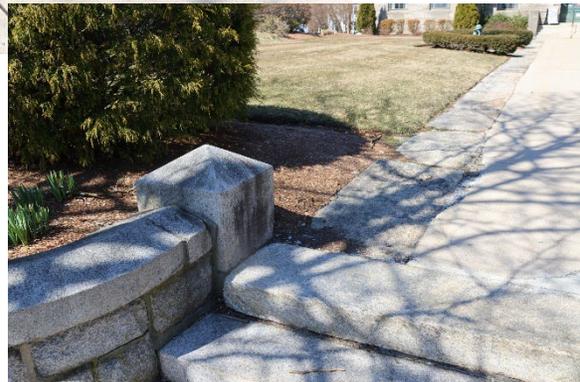
The main walkway and surround are also deteriorating.

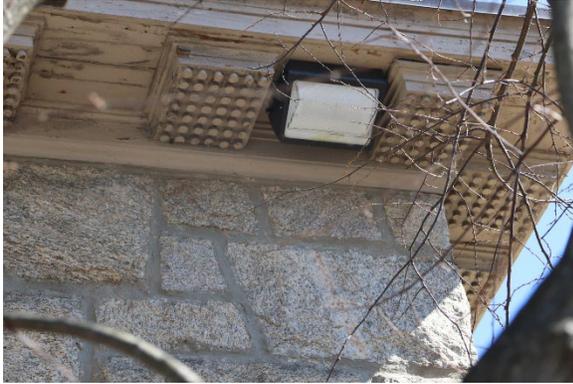
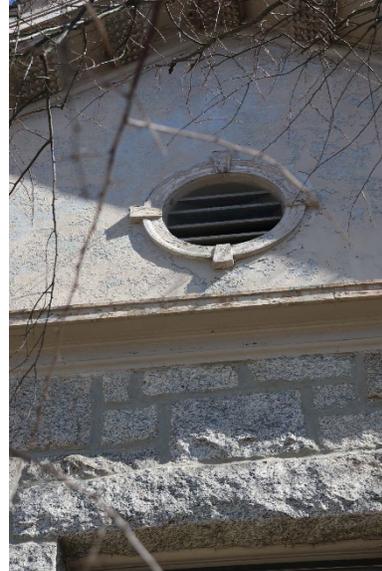
Trim needs repair and paint.
Lighting requires modernization.

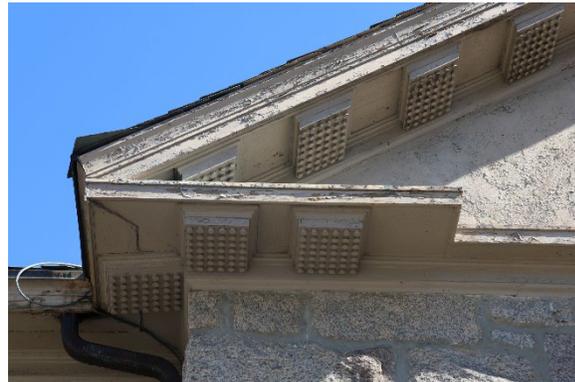
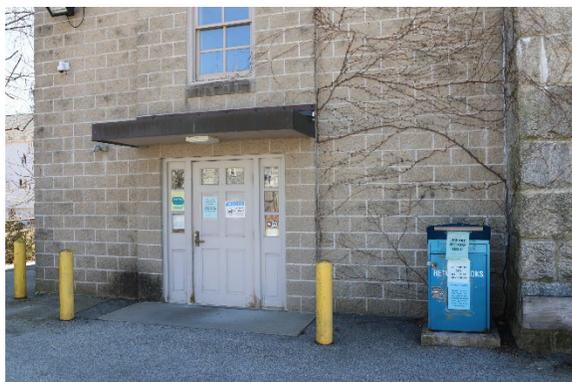
The book return bin is walk-up, not drive up.

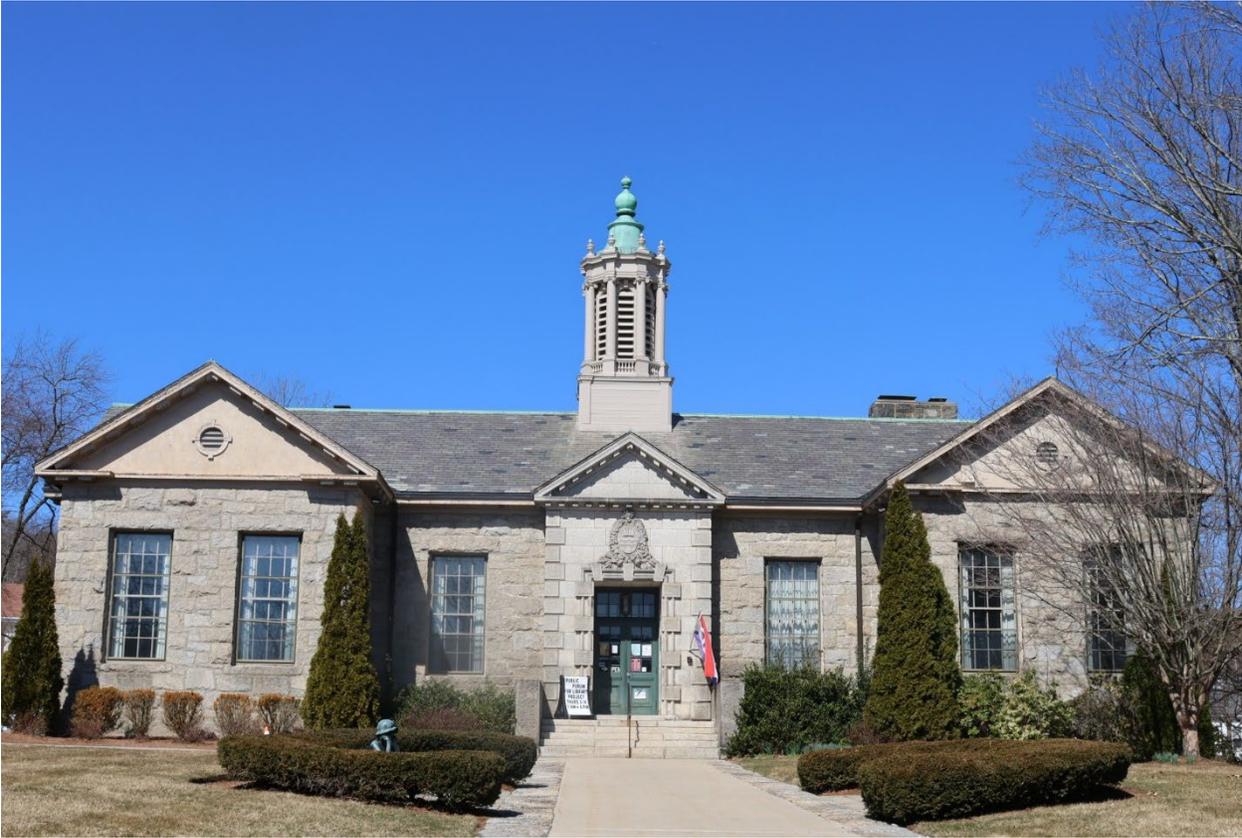
Characterized in the National Register of Historic Places Nomination form for the Downtown Northbridge Historical District (1984) as “Perhaps the single most elaborate civic building” in the district is the 1913 Whitinsville Social Library. Per the application:

It is a one-story [Milford] granite Neo-classical building located near Memorial Square. Hipped-roofed, with its broad side facing the street, it has slightly protruding pavilions at each end of the façade topped by cross-gables with returning eaves. Its central doorway is ensconced in a smaller projecting pavilion decorated with a pediment, vermiculated quoins, and a vermiculated Gibbsian surround around the door itself surmounted with a cartouche. Rising from the center of the roof is a circular belfry, with iconic columns interspersed between louvered round arches supporting an urn-encrusted entablature that is capped with a massive copper finial. (p.4)

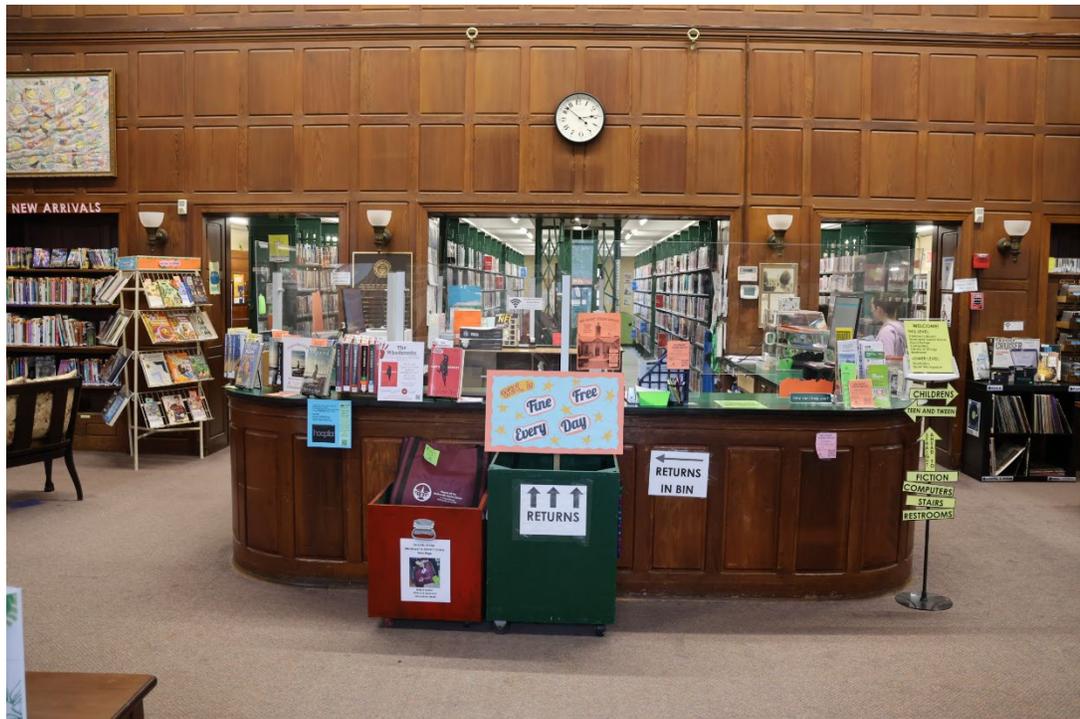
Patrons enter the symmetrically designed, wood paneled main service area anchored by the central circulation desk. The central area comprises one half of the space with Teen and Tween area occupying the west quarter and Children's collections occupying the east and quarter. The intricate hand-made carvings and wood paneling are crafted from California redwood.

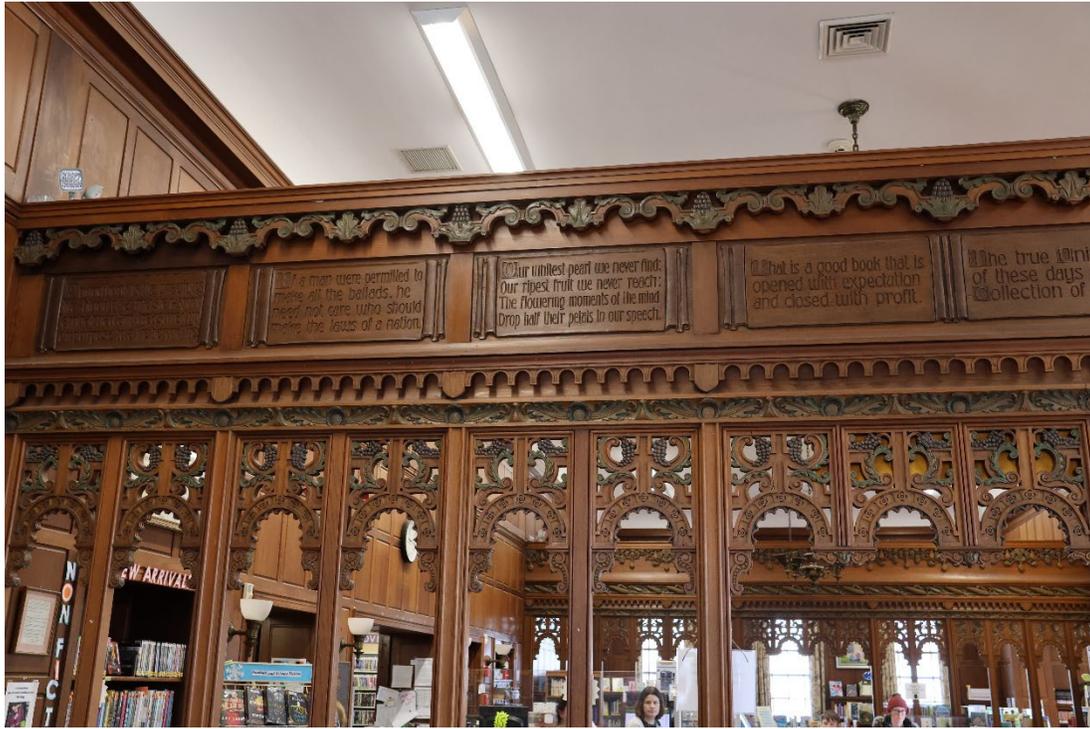
High ceilings and modern florescent lights help to offset the dark atmosphere created by the paneling.

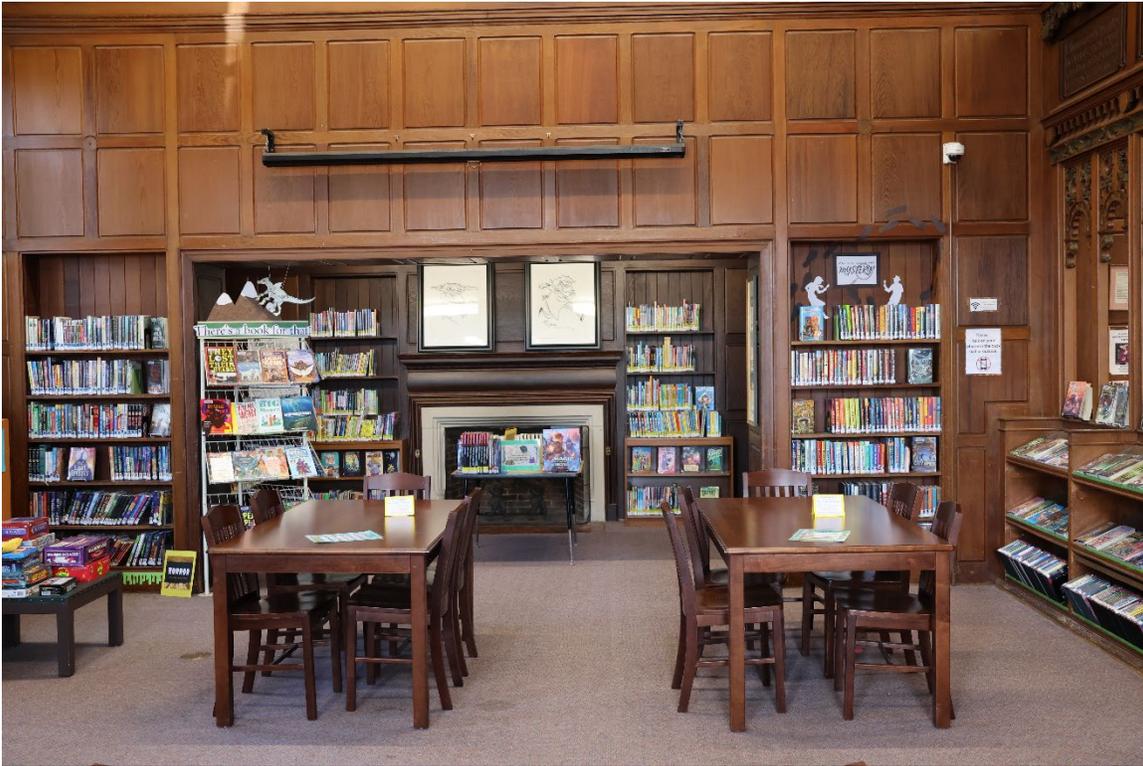
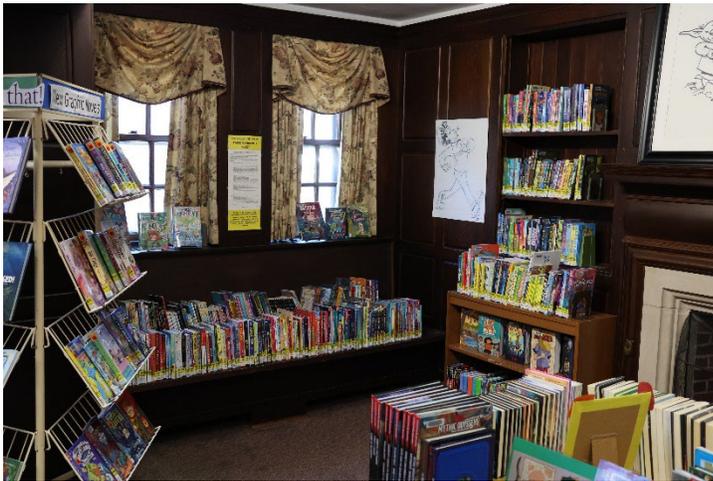
The west portion of the main floor is devoted to the Tween collection and to program presentation space using the pull-down projection screen. Furniture must be moved for every program and sound from all programs permeates the main service space and Children's Room.

The fireplace nook contains portions of the Tween collection. Public Forum and Focus group participants requested that the benches holding books be returned to their original use as cozy reading niches and that the fireplace be useable. The space is open to young adults only weekday afternoons.

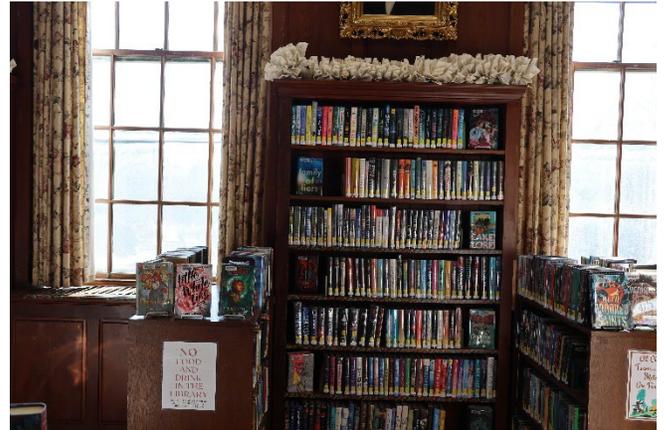
The west window wall contains additional Tween shelving.

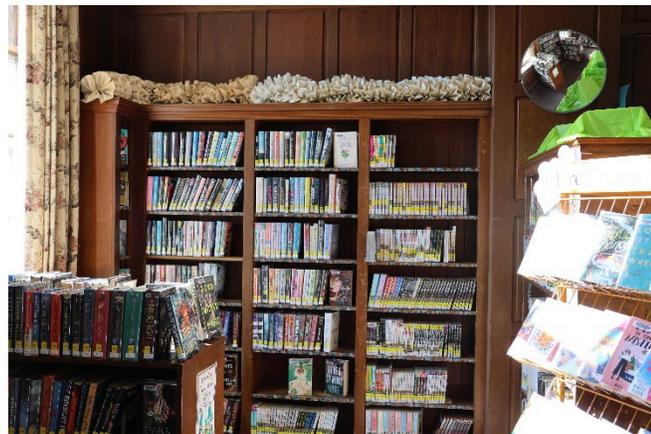
The alcove at the front of the room, replicating the fireplace nook, holds the Teen books.

The carved arches serve well to display books.

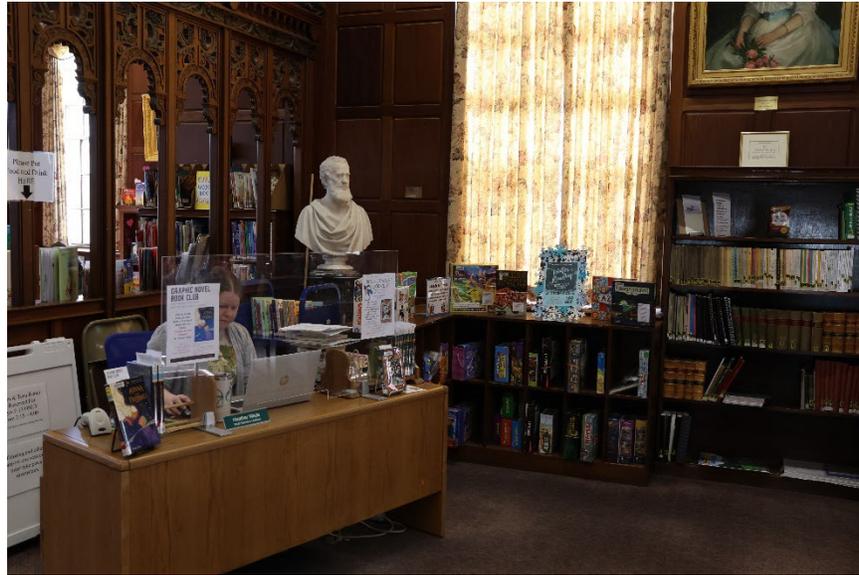
To the right of the main entry is the Children's Librarian's desk. Note the lack of staff work area and privacy. Directly behind the desk is the Children's Room. Although the space is visually set off by panel, there is no sound barrier.

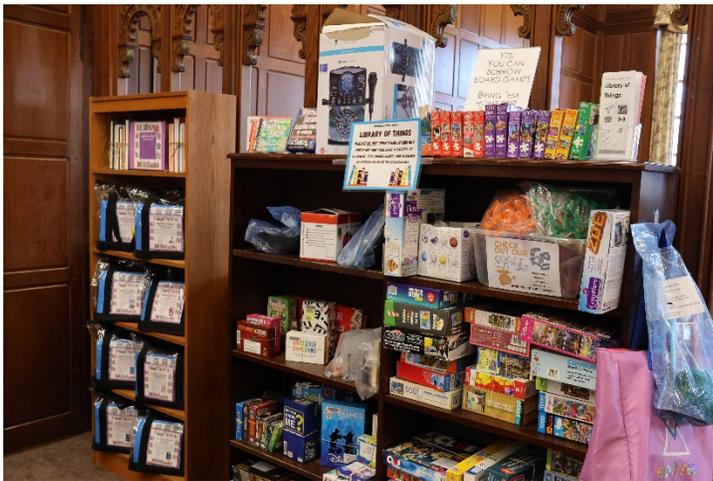
Directly outside the Children's Room, between the entry and the Circulation Desk, is the Library of Things, stored randomly as space permits.

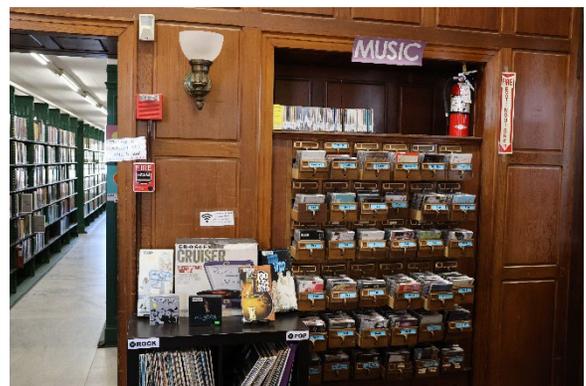
It adjoins the music collection which demonstrates adaptive reuse of the card catalog. The door leads to the stacks.

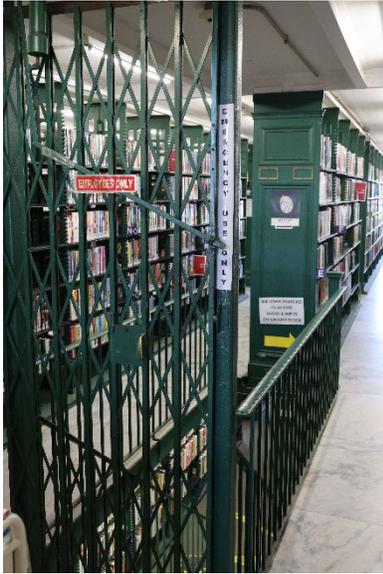
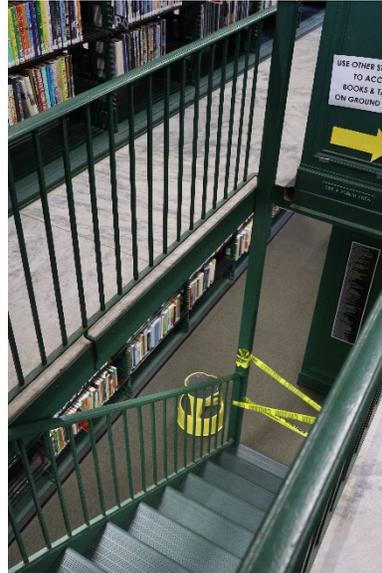
The original cast iron stacks occupy two levels in the building, connected by metal stairs which are blocked for safety. The structure supports the roof. Adult Fiction is shelved on the upper level and Non-fiction on the lower level.

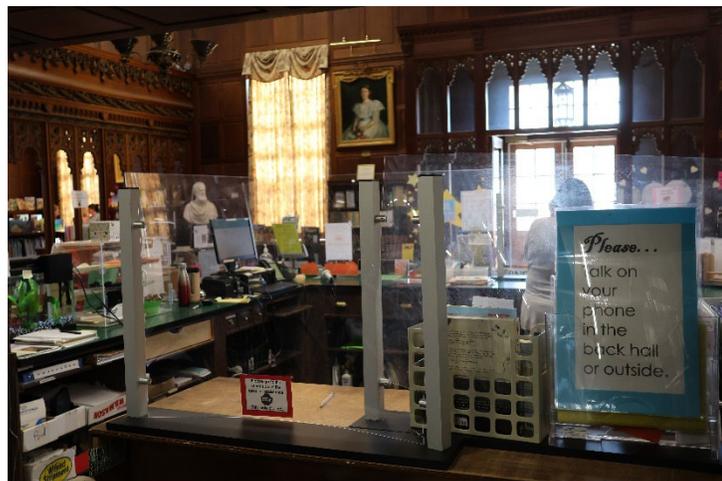
Visible in the photo above is the opening to the Circulation Desk from the stacks.

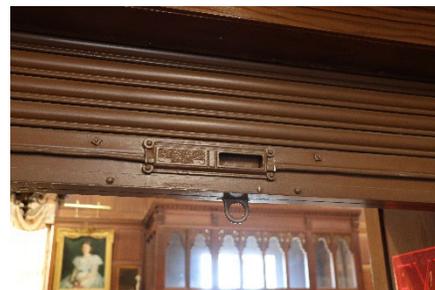
When the library was constructed, the stacks were closed and all materials were retrieved by the staff. A pull-down divider (right) allows the desk to be closed off from the stacks.

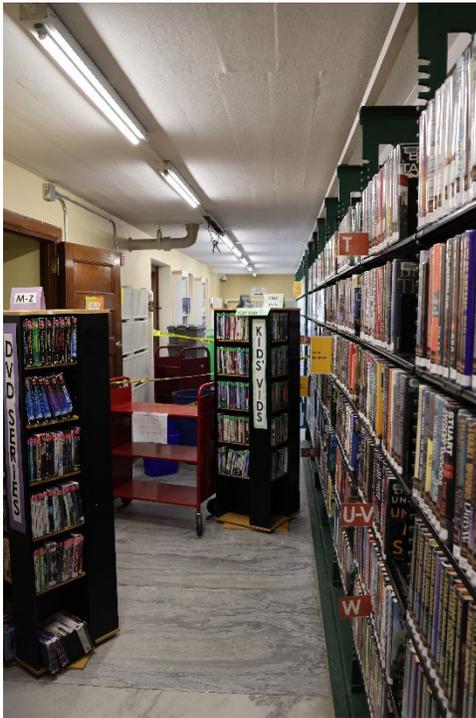
The west wall on the main floor suffered water damage from a leak through the lights, which has been repaired. Visible to the right is the door to Technical Services and beyond it DVD shelving. Radiators line the wall.

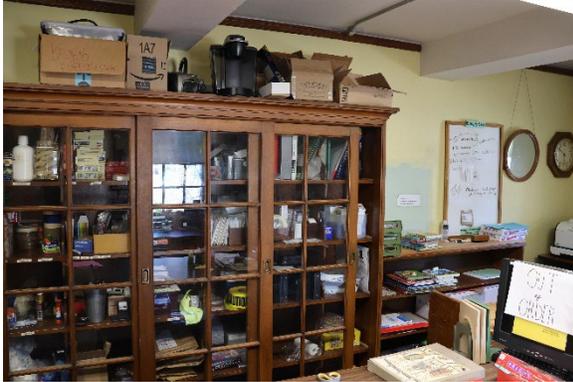
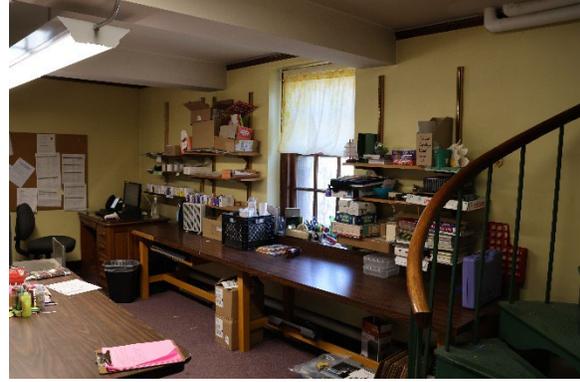
A spiral staircase leads from Technical Services to space above the Young Adult Room, which now is storage. It is the only path to the space and is not accessible.

Technical Services storage on the left and spiral stair to storage rooms above on the right.

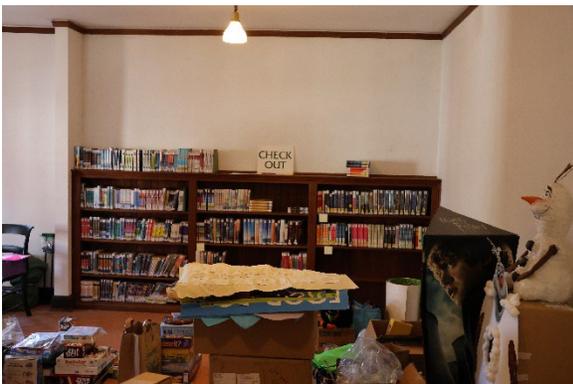
Views of the room at the top of the spiral stairs, used for storage. The books on the shelves labeled “Check Out” are duplicates as well as copies of former school summer reading books which remain in the catalog

but cannot be shelved in the main stacks due to lack of space.

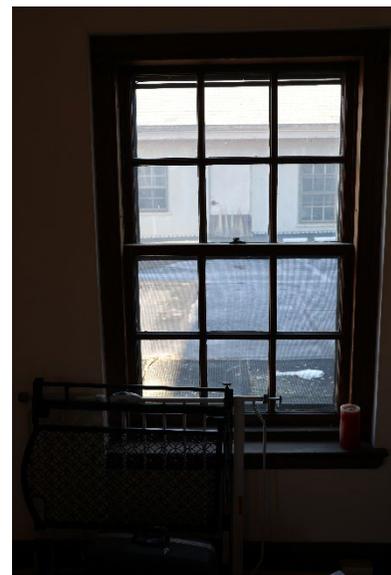
The window at the top of the spiral stairs looks across to the door which opens onto the roof from the Archival Room but does not give roof access.

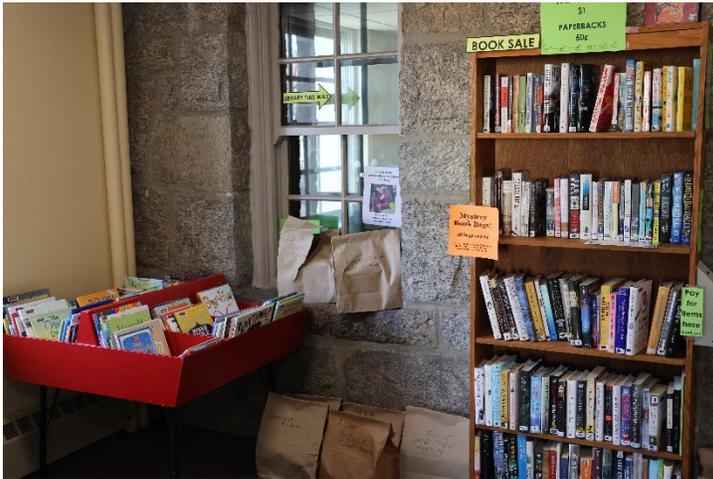
The original wall opposite the elevator is used for Friends Book Sale. The windows open into the Library Director's Office.

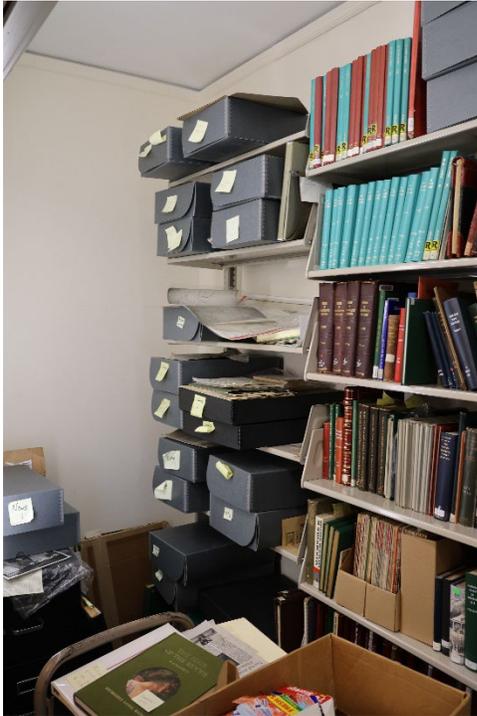
Shelving in the closet is limited and not climate controlled.

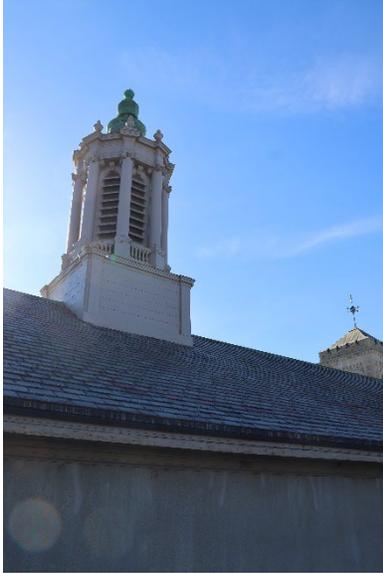
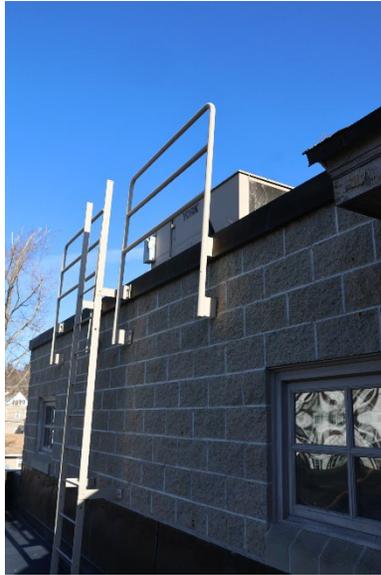
Both the cupola and the roof housing elevator equipment may be reached from the door.

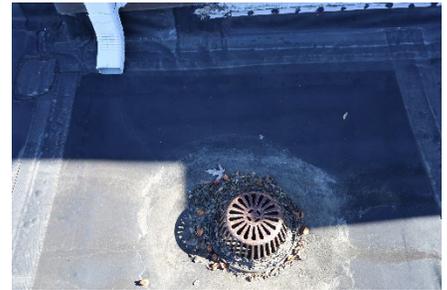
The drain below must be cleaned regularly to prevent flooding.

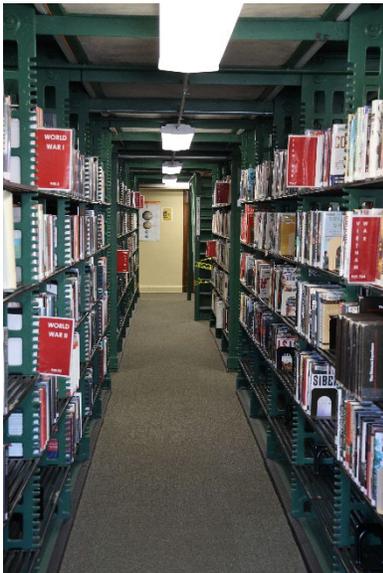
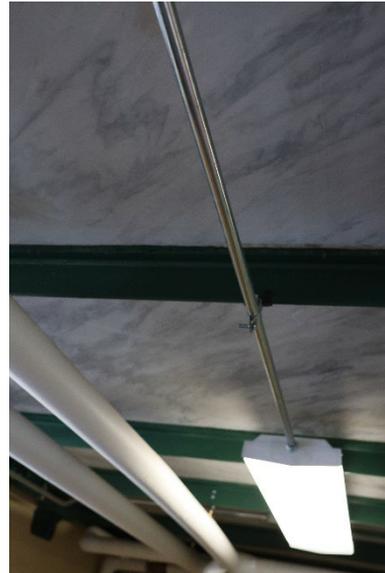
Enter the stacks and look up to see the cast iron framework supporting the marble tile floor on the main level. Heat pipes and electrical conduits are open to the public view.

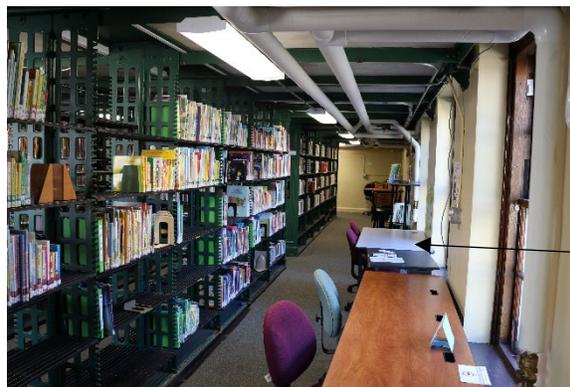
The arrow points to a door leading to storage space under Technical Services.

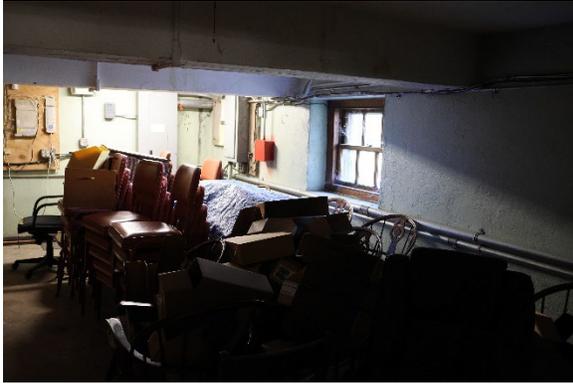
Unused furniture, architectural elements, and a plethora of other items land here. The room leads to more storage in the fallout shelter which continues under the main service area.

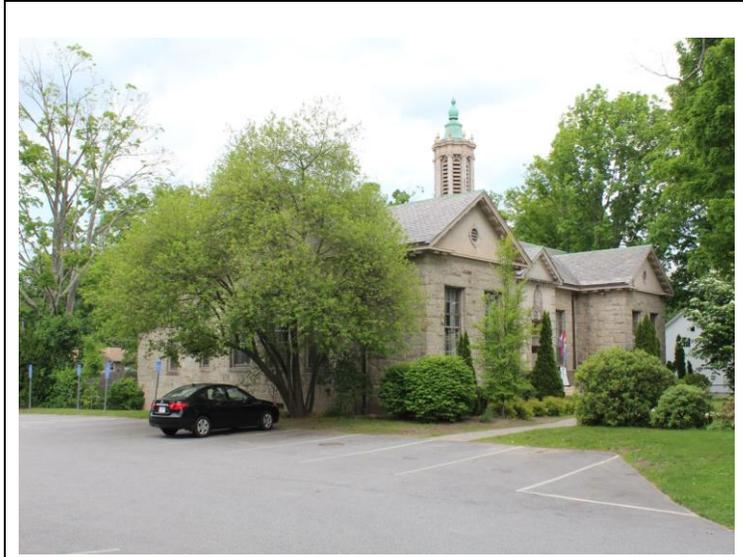
Image 1, South and West Elevation

The building is set on a horizontal, board-formed, concrete foundation with a small recessed shelf carrying the stone veneer. The symmetrical main south elevation (*Image 1*) is two bays, three bays and two bays. The main, rusticated entry, pedimented pavilion is capped with a full pedimented gable roof and granite modillion blocks. The projecting pavilion, clad in smooth granite, has a series of granite quoin blocks defining the edges. The recessed door, with double six lite, raised lower panel, is topped with an eight lite transom and is trimmed with molded granite pilasters. The pilasters are broken with quoins, topped with three carved keystones and, the library-coat of arms centered in granite and containing a carved seal of corn and grapes, designed by Sturgis.

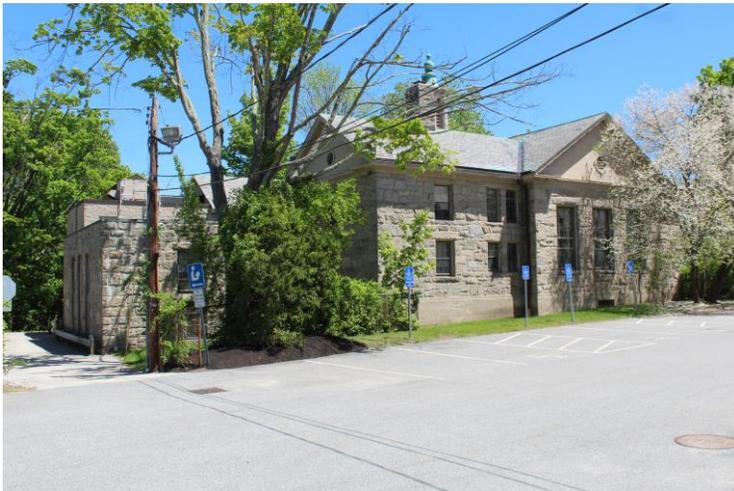
Image 2, West and North Elevations

The one story, Colonial Revival building was design by architect R. Clipson Sturgis who designed Brookline's public library and Boston's original Federal Reserve Bank. The commercial building's original footprint is T-shaped with short, two-foot, projecting wall pavilions as part of the upper T and a small northwest 23 by 25 foot area where the T's rectangular top 88 by 30 foot and rectangular leg 38 by 54 foot join. In the northeast corner is a 23 by 26 foot mid-1990's addition for an elevator and new fire egress stairs and bathrooms, finished externally with rough split faced CMU's capped with a flat roof and HVAC equipment. (*Image 2*)

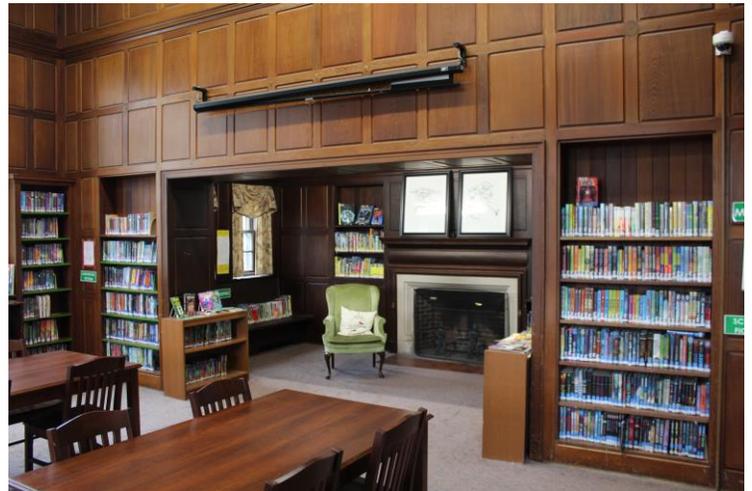
Image 3, Interior West Sitting Room

The library's interiors use redwood for ceiling and flooring finishes. There is white marble flooring in the stacks area. Library shelves used cast iron uprights to not only support book collections but the steel I-beam holding the concrete floors above. On the first floor are two carved redwood screens which partition off the adult sitting areas and the children's reading areas. The carved screens have pears, grapes, and corn carved, painted woodwork. Joseph Hetherington, an English immigrant, has been credited with the interior redwood carvings. There are also raised redwood wall panels, some natural and some stained dark. The west sitting area has a centrally located fireplace (*Image 3*). The second floor houses the Northbridge Historical Society's local history collection.

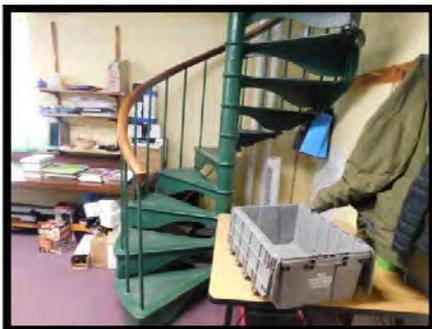
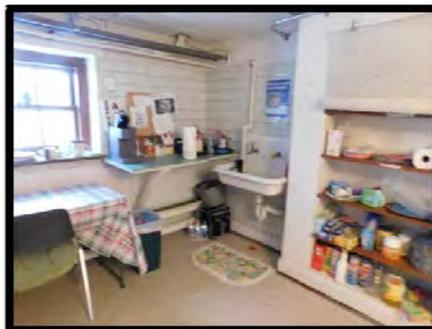
The Level 1 Staff Work Room has a spiral staircase to a mezzanine storage area with open risers and railings that are too low, lack extensions, and provides only one railing. The Ground Level Staff Kitchen has a sink with exposed piping, a sink basin that is too deep, and faucets that require pinching and twisting of the wrist. As these areas are closed to the public and used solely by library staff, future modifications would only be required as a result of a reasonable accommodation request. *See Photos Below.*

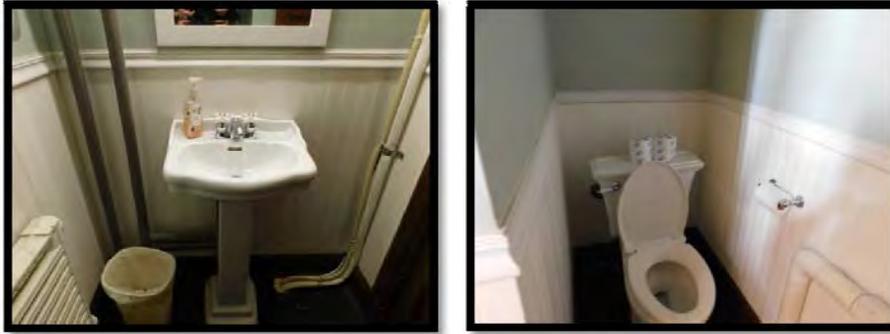
Library Director's Bathroom. The Library Director's Bathroom is wholly non-compliant with inadequate clear width at the water closet and insufficient maneuverability. The sink is pedestal-style thereby lacking knee depth. In addition, the faucets require pinching and twisting of the wrist. The mirror and the soap dispenser are too high, the toilet paper dispenser is too close to the front of the water closet,

the lights are operated using a pull chain that is not within reach range and also require pinching and twisting of the wrist, and the water closet lacks grab bars. As this bathroom is used solely by and at the discretion of the Library Director, no other action is required for this bathroom at the present time, unless necessitated by a reasonable accommodation request. *See Photos Below.*

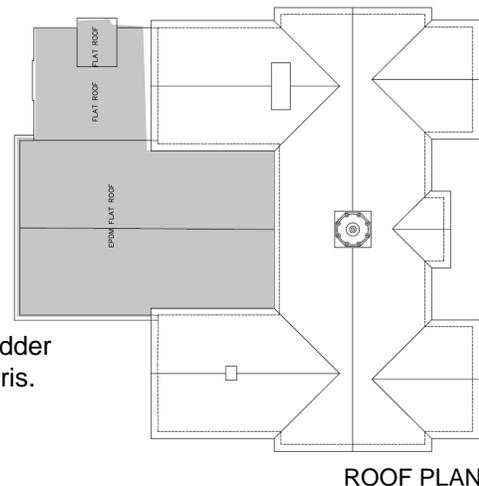
1 Membrane Roof

The location of the membrane roof area is generally shown in the grey area of the roof plan diagram to the right. This membrane roofing system is located over the stack areas, elevator, and the northeast corner addition to the facility. In conversation with staff, it was noted that some leaks are active and need to be addressed. Rubber walkway pads appear to be missing leading from the access doorway to the vertical ladder access. Roof drains appear solid and clear of debris.

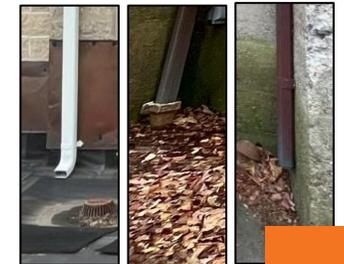
Rain leader systems appear in serviceable order. Some tie via boot connectors to underground stormwater systems, some shed directly to ground discharge, and others directly shedding to flat roof areas ultimately discharging to roof drains. Given that the conditions of underground systems cannot be evaluated, the study team recommends scoping of these systems to ensure adequate capacity and flow. For those systems spilling directly to grade controls such as splash blocks to minimize building splash should be considered. For those at roof surfaces, roofing system recommendations (possibly requiring additional rubber slip sheets at point of discharge) should be considered.

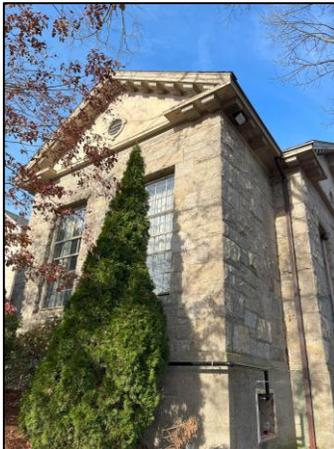
2 Wood and Stucco Trim

The wood facias, eaves, vents, and window surrounds (sample image shown to the right and adjoining page), are in poor to fair condition. The wood substrate must be inspected to confirm that it is solid, and not water damaged. Surface prep should include necessary wood repairs, patching and filling, scraping and preparation of remaining solid surfaces. Generally, painting is needed for these surfaces. The stucco areas of the gable ends of the sloped roof areas similarly are in poor to fair condition. This area must be inspected for soundness of material, or evidence of any water damage. Painting preparation and finish painting work is needed for these surfaces.

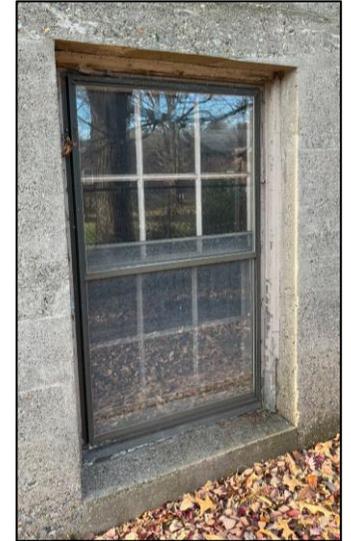
WINDOW UNITS w/ STORM SASH,

Window systems found in the 1913 library construction are wood window systems overlayed with full opening storm sashes. The windows are old, but in good condition. Individual sashes should be tested for operability issues. The heads, sills, and jambs should be inspected for substrate condition, solidness, and evidence of any water damage. Repair, patching, and filling of the wood material should be undertaken prior to painting preparatory work. Scraping of loose and flaking paint is required. Perimeter sealant and painting is needed for these surfaces. Newer vintage windows are located in the north and east Elevations. These are thermally insulated double-hung units. Generally speaking, their condition is seen as good, and do not require the attention described above.

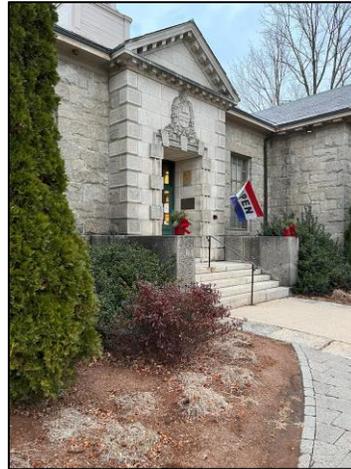
ENTRY | SOUTH ELEVATION

The existing granite stair located at the library's main entrance is observed to be in good condition with normal wear for a set of stairs of this vintage. Some sealant work at the interface of tread and riser should be considered. The Center-stair wrought iron rail is in good condition with Minimal evidence of rust evident. Repainting of this rail may be considered as part of an on-going maintenance plan. NOTE: A key concern regarding this entrance is its lack of compliance with Americans With Disabilities Act (ADA) Regulations, guidelines, and standards. Generally speaking, an accessible pathway from the public way and parking area are required. However, due to the historic nature of the main entry, we recommend seeking a variance to minimize the changes required. Typically, accessible pathways, ramps to gain access to the main entrance level are needed. An exterior arrival platform able to accommodate wheelchair access, and an entry door system with pull force level requirements meeting ADA standards. The stairway, if remaining, likewise must comport to riser and tread dimensional and configuration guidelines, and the handrails must be located and configured in accordance with these guidelines.

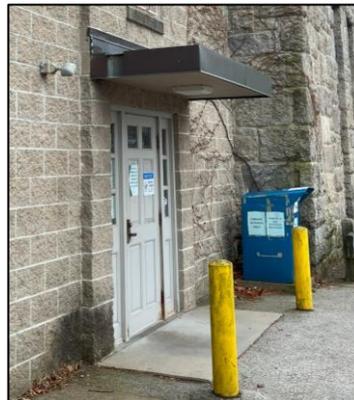
ENTRY | NORTH ELEVATION

This entrance serves as the library's accessible entrance with available accessible parking identified in the adjacent Parking lot. The door system is relatively new and in good working order. Pull force level requirements should be Reviewed and confirmed to assure compliance with ADA Standards. Some wear is evident on the lower hinge-side of the door, and the base of the hinge-side sidelight unit. Some wear is evident on the lower latch-side door jamb. Patching, repair, and repainting is suggested.

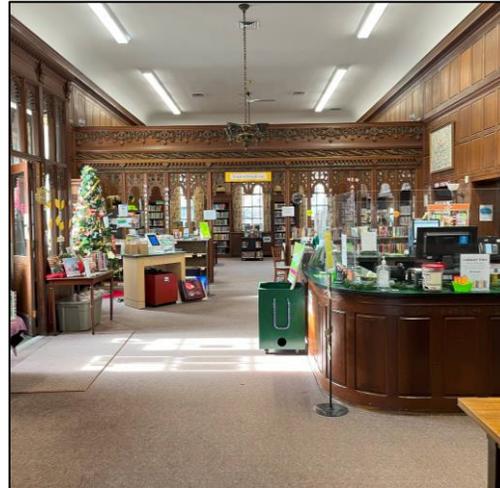
AREA A | TYPICAL INTERIOR FINISHES

The floor system found throughout Area A is wall-to-wall, commercial-grade loop pile carpeting. The carpet is in fair to good condition and may be considered for replacement.

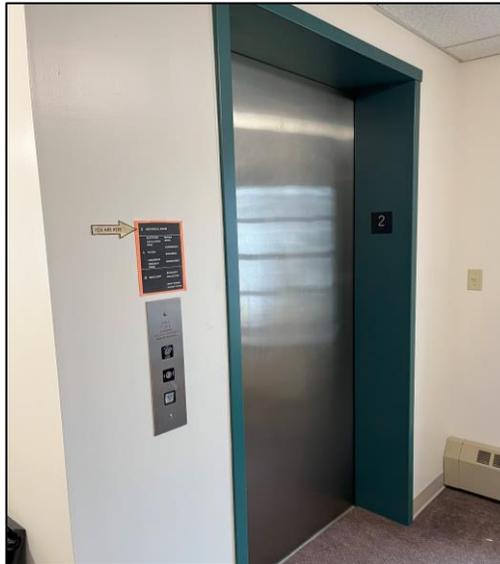
AREA B | TYPICAL INTERIOR FINISHES

The floor system is wall-to-wall, commercial grade loop pile carpeting. The carpet is in fair to good condition.

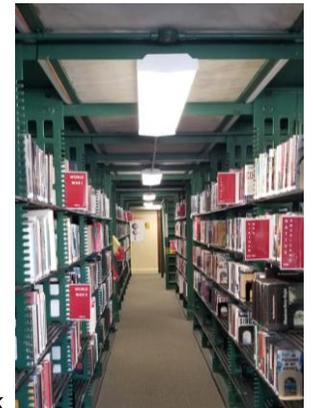
AREA C | FINISHES

The floor system found throughout Area C is concrete (lower level) and marble floor panels and metal book stack system (first-floor level) that are in good repair and condition.

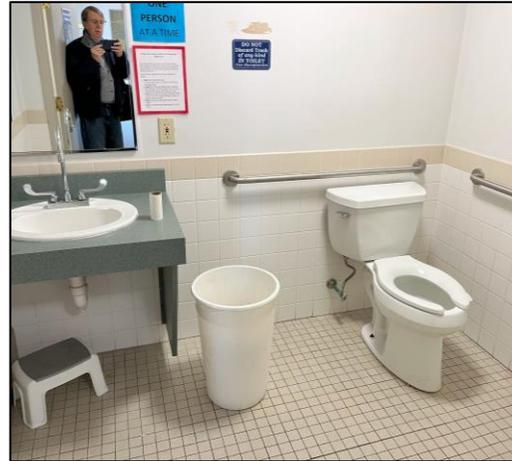
HC ACCESSIBLE TOILET ROOM

An ADA compliant toilet core is located at the first-floor level of the library in the northeast corner of the facility. The toilet room has ceramic tile flooring, with a ceramic tile wainscot. The drywall walls above the wainscot are painted. The fixtures are accessible, and the sink area allows for wheelchair use. The room is sized adequately for wheelchair turning radius accommodation.

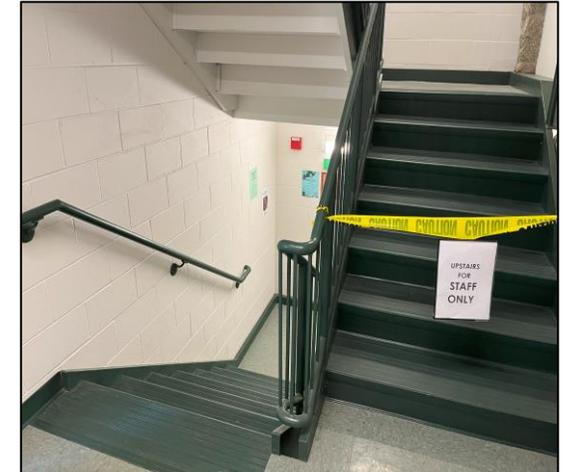
NORTHEAST STAIR

The stair is a metal pan stair with rubber stair treads and risers. The main landings and intermediate landings carry a VCT finish with rubber cove base. Handrails are painted metal with appropriate extensions at landings. The guardrail is painted metal with a vertical picket configuration. Walls are painted CMU and In good condition.

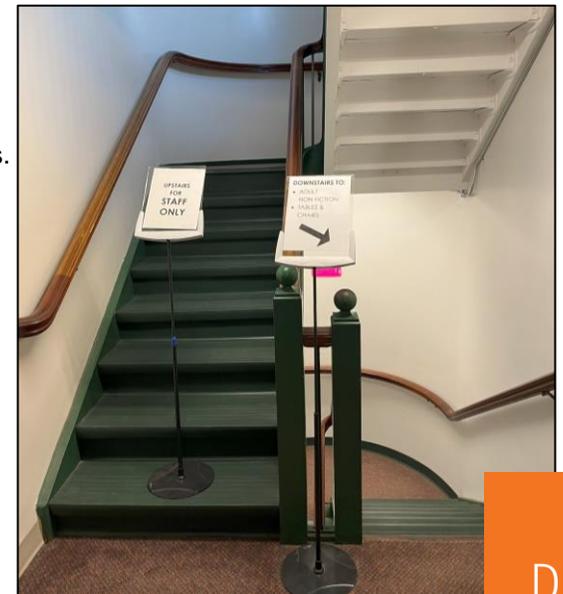
AREA A STAIR

The stair is a metal pan stair with rubber stair treads and risers. The main landings and intermediate landings carry a carpet finish with rubber cove base. Handrails are wood and may require modification to attain appropriate extensions at landings. painted metal with a vertical picket configuration. Walls are painted plaster And appear in good condition.
