Building Program

WHITINSVILLE SOCIAL LIBRARY

NORTHBRIDGE'S PUBLIC LIBRARY

prepared by
Mary E. Braney
Library Consultant

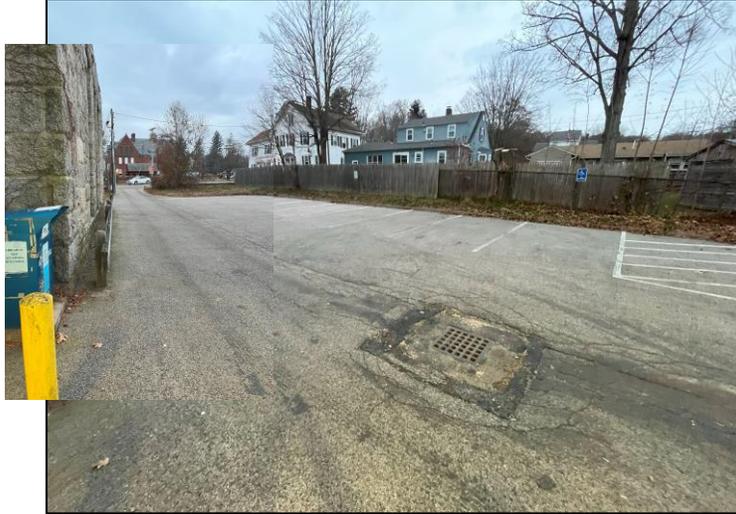
PHOTO 1 | North Parking – View to West

The on-site library parking area is located to the north of the property, and contains nine (9) striped parking spaces inclusive of two (2) that are designated as handicap parking spaces. This parking area and its connection to the adjacent church parking area to the west are shown in photographs 1 and 2 to the right, and are located on the facing page aerial photograph.

Note: Photograph 3 depicts parking spaces and handicap parking spaces that are located on the adjacent church Parking lot. Photograph 1 shows a driveway connection to this parking area that is not part of the library site.

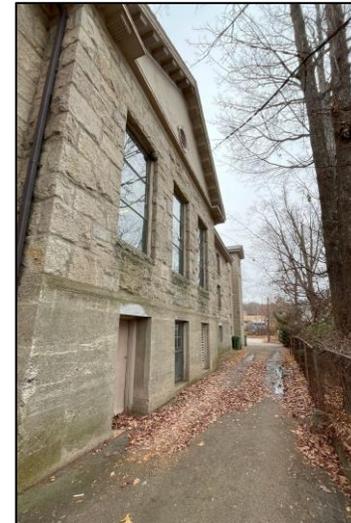
PHOTO 4 | East Drive

The driveway which connects Church Street to the north parking area along the eastern property line of the library site. This driveway is shown in photographs 4 and 5 to the right, and are located on the facing page aerial photograph.

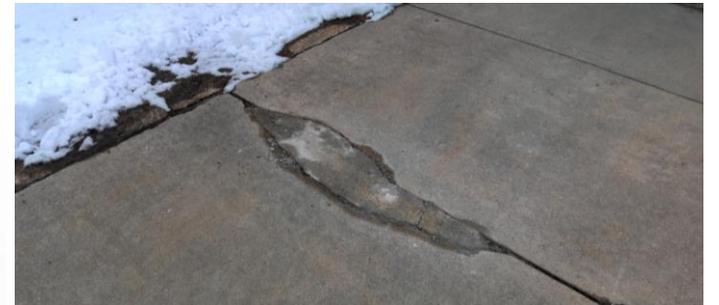
The pedestrian walkway at the south main entrance is well kept and in good condition. This path is not accessible as it leads from Church Street as it is interrupted by sets of stairs at the street and again at the main entry without an accessible ramp system, or a compliant lift. Normal routine maintenance is evident and needed on an on-going basis.

TYPICAL REPAIR AT SIDEWALK

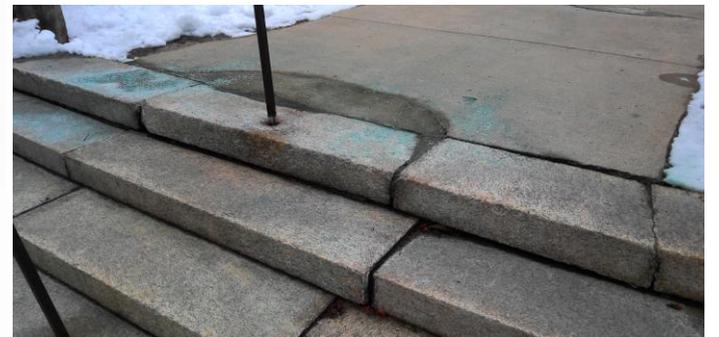
TYPICAL REPAIR AT SIDEWALK / STAIR

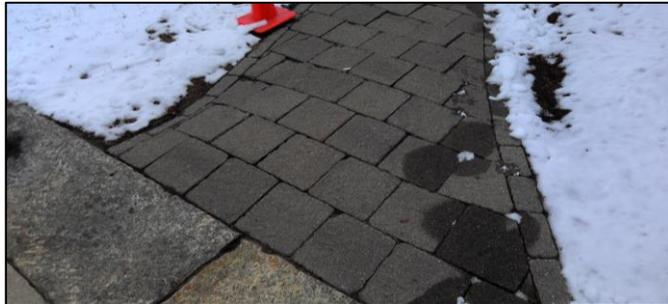
The pedestrian walkway at the south walk leading to the church parking area is in fair-to-good condition. This path is not accessible as it leads from the parking area without a properly marked walk aisle, or attendant HC parking dedicated to the library entry. This walk is also not accessible due to its interruption by sets of stairs at the main entry without an accessible ramp system, or a compliant lift. Normal routine maintenance is evident and needed on an on-going basis. Due to the individual paver block pieces, more water infiltration is likely leading to increased frost heaving in this walkway.

SIDEWALK – FROST HEAVE CONDITION

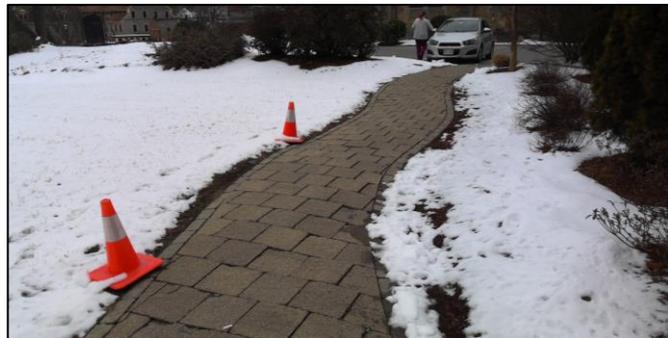
SIDEWALK – VIEW TO CHURCH PARKING LOT

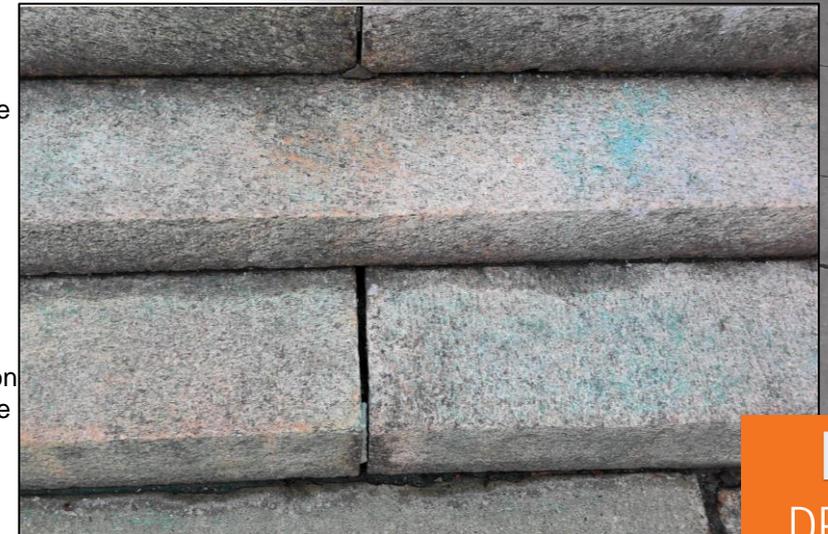
The granite stair at the main entry is in fair to good condition. Wear consistent with the age of the installation is evident. Requirements regarding HC accessibility are noted on page 14 of this document. Regular repointing of grout and caulking maintenance are suggested to maintain the condition of the existing stair.

STAIR TREAD AT MAIN SNTRY

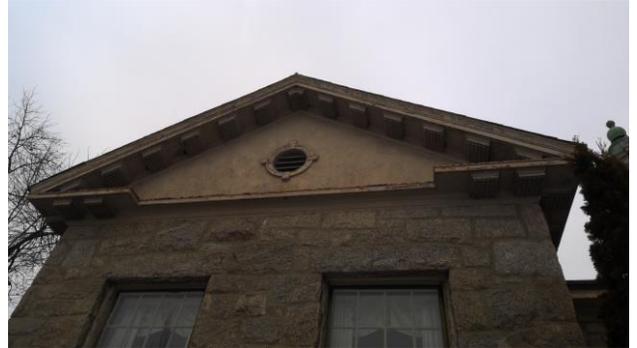
6. NORTH ELEVATION – STUCCO GABLE

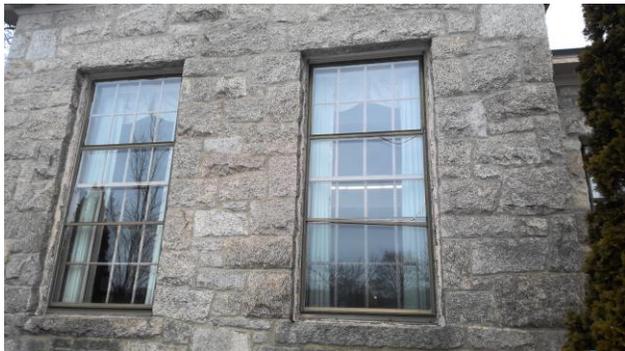
7. WINDOWS W/ STORM SASH

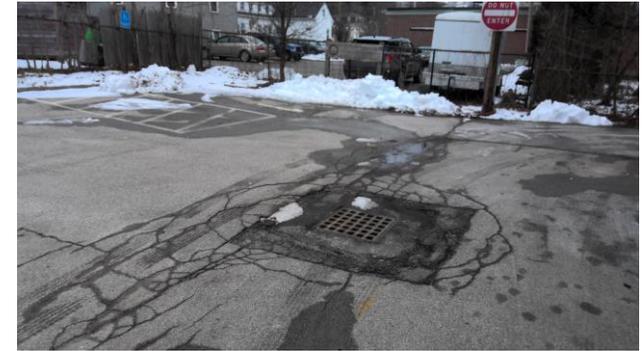
12. NORTH PARKING – PAVEMENT CONDITION

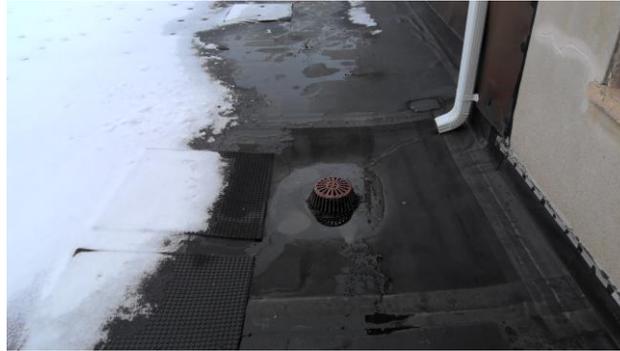
20. ROOF DRAIN – FLAT ROOF

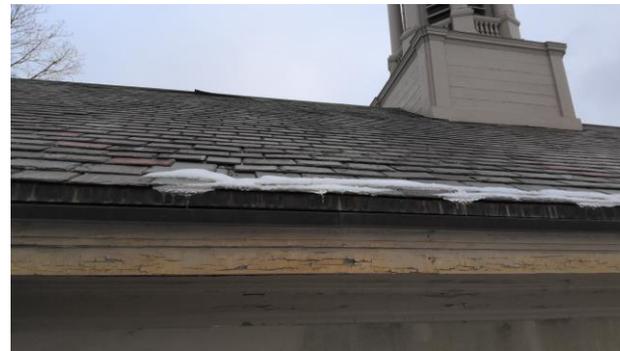
23 . SLATE ROOF – EAVE CONDITION

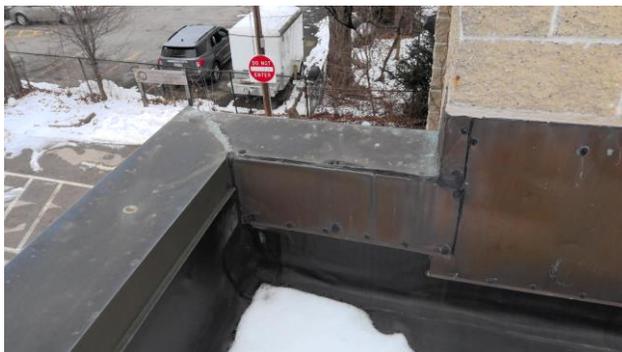
25. FLAT ROOF COPING AND FLASHING

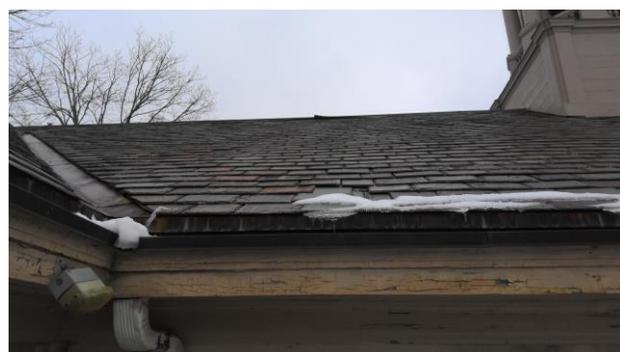
26. SLATE ROOF – COPPER VALLEY FLASHING

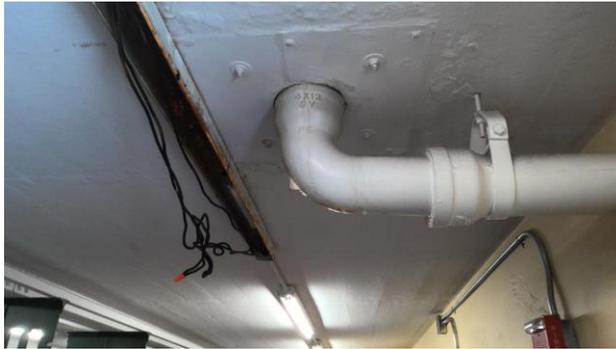
54. FIRST LEVEL – STACK AREA – WATER INFILTRATION

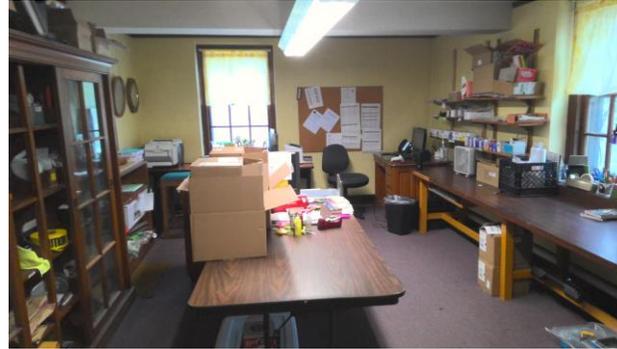
55. FIRST LEVEL – WATER INFILTRATION

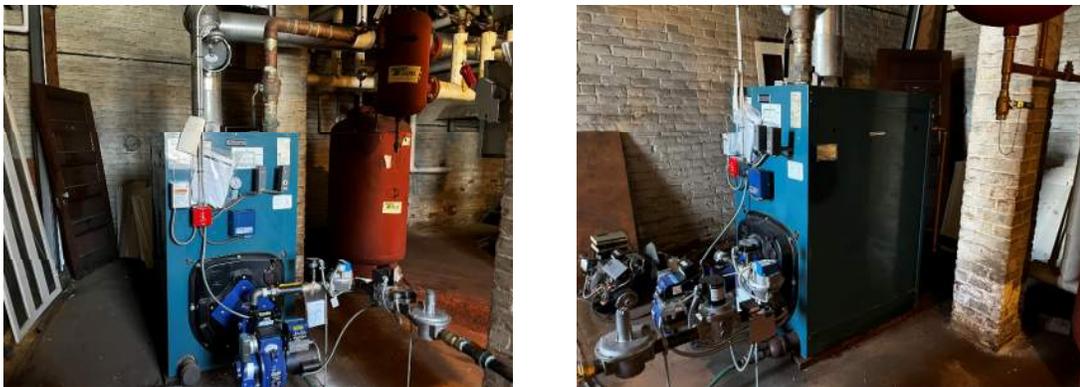
Single Gas Fired Standard Efficiency Boiler

Building heat is provided by a single gas fired standard efficiency boiler. The boiler was manufactured by Burnham model V906A having an output capacity of 703 MBH. The boiler was installed in 2001 and was originally fitted with an oil-fired burner. The burner was recently replaced with a gas fired burner. There are two oil storage tanks that were left behind and no longer piped to anything.

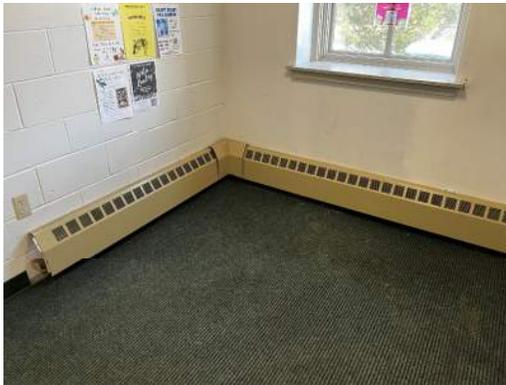
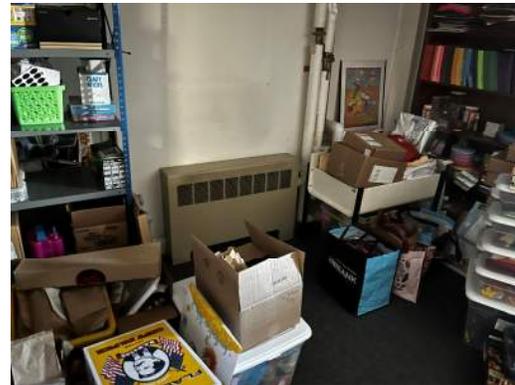
Fin Tube Radiation and Convector

The heating hot water is pumped through the building by in-line dedicated zone circulators. There are (4) four circulators serving (4) four zones. Insulated copper piping distributes heating hot water throughout the building to cast iron radiators, fin tube radiation, and convectors. The cast iron radiators are exposed to the public and can be very hot to the touch.

- Pumps 1 and 2 appear to be near or beyond their serviceable life. Pumps 3 and 4 look to have been recently replaced.
- There are signs of wear and tear on some terminal heating devices. However, the terminal heating devices does appear to be in good working order.

- Recommend replacing pump 1 and 2.
- Recommend installing some type of buffer cover over the cast iron radiators to prevent direct contact with the heating element.

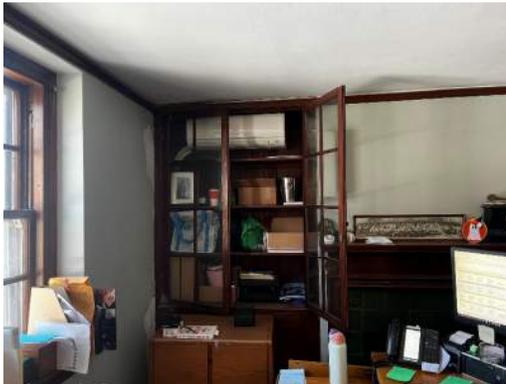
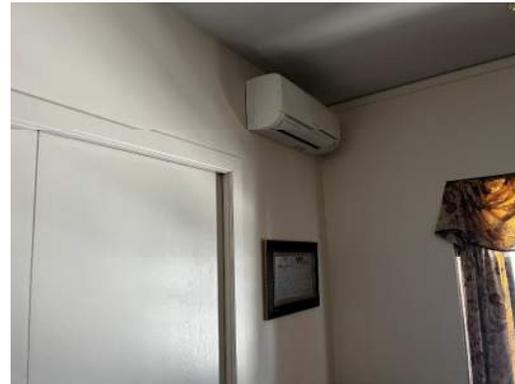
Space cooling is performed by a combination of ductless wall mounted units and a single roof mounted unit. The ductless wall mounted units share a single outdoor condenser mounted to the exterior wall. The wall units are located in the main office and a meeting room.

Wall Ductless Cooling Units

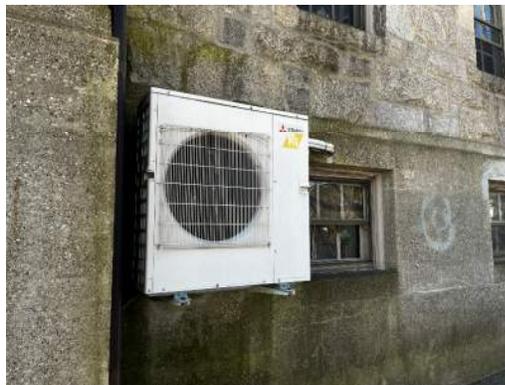
Outdoor Air-Cooled Condenser

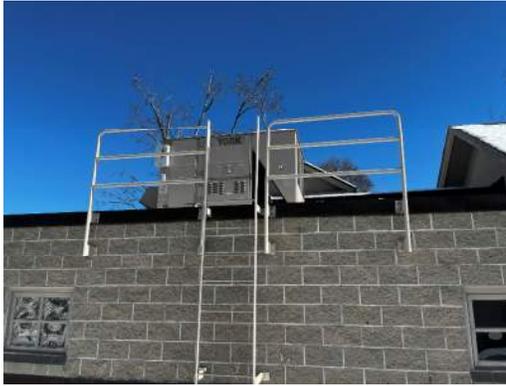
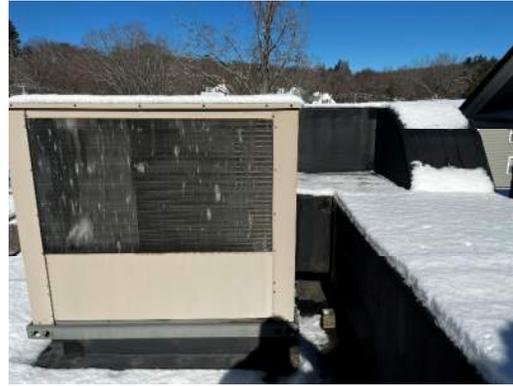
Roof Mounted DX Unit

There is a 7.5-ton roof mounted unit DX unit manufactured by York that serves the front of the library. The conditioned air is distributed via an insulated galvanized sheet metal ductwork system. The ductwork system terminates with ceiling mounted diffusers.

The building does not appear to be fully air conditioned as the ductwork system does not extend to the lower and upper book stacks or any of the side office spaces.

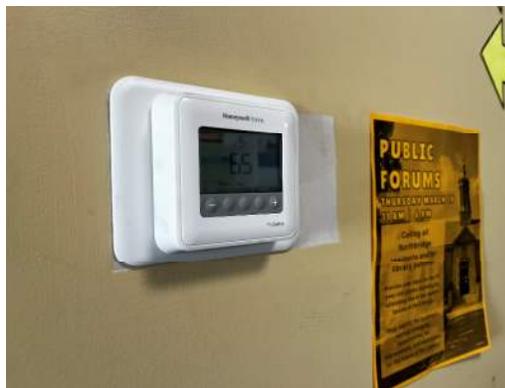
Local standalone programmable thermostat control.

Standalone Programmable Thermostat

- A capital project is recommended to upgrade standalone thermostats to a building wide automated temperature control system. An upgraded ATC system can provide improved temperature control, building scheduling and building

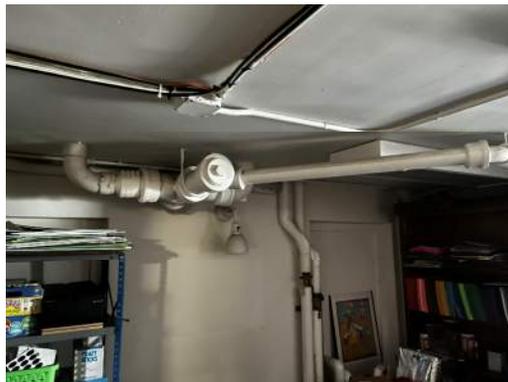
Typical Sanitary Waste Piping

- In general, the majority of sanitary piping is outdated and has exceeded its life expectancy. It is recommended all sanitary piping to be replaced as renovations are completed.

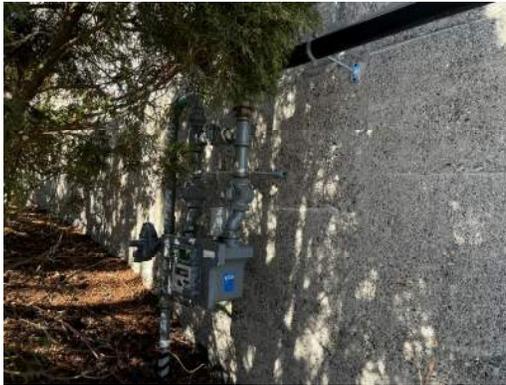
- In general, the gas system appears to be in good condition. The exterior service itself is also in good condition.

Gas Meter Assembly

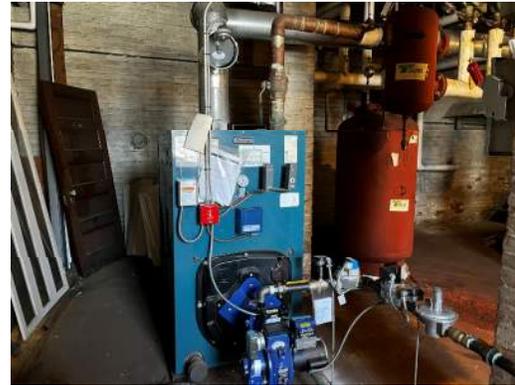
Gas Piping to Boiler in Mechanical Room

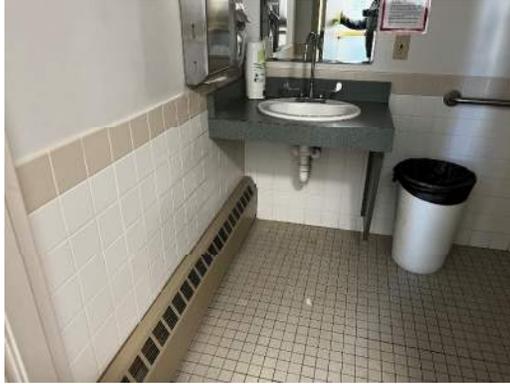
- All water closets and lavatories appear to be in good condition.
- The sink and faucet in the staff lounge appear to be in fair condition.
- The floor drain in the mechanical room is old but still appears to be operational.
- Drinking fountain appeared to be in good condition.

Typical Public Lavatory

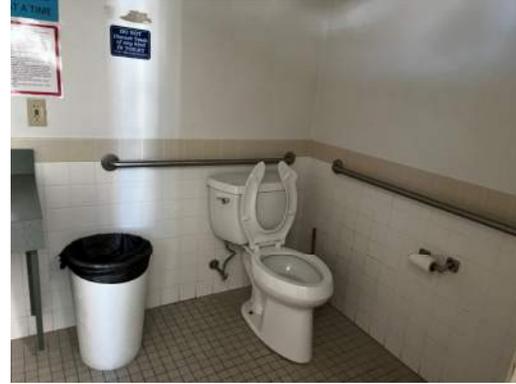
Typical Public Water Closet

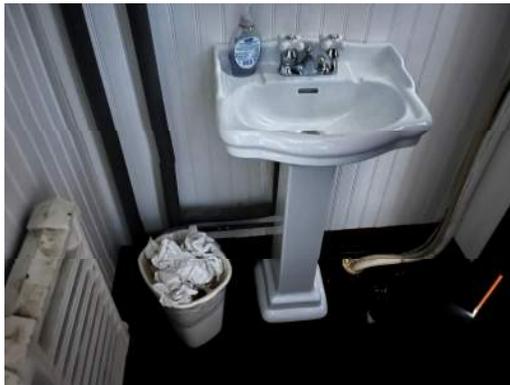
Private Lavatory

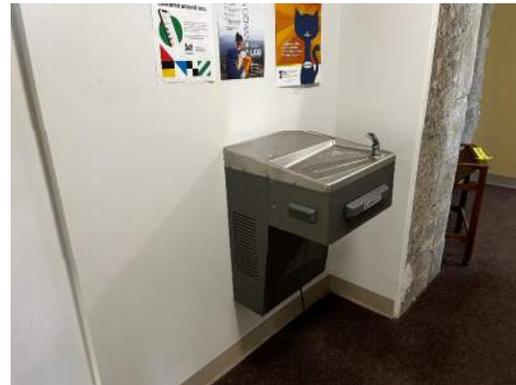
Drinking Fountain

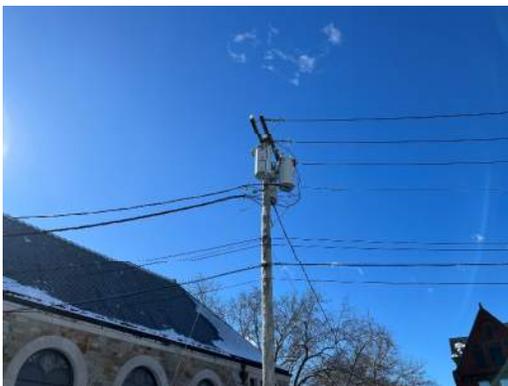
- The electric service from visual observation appears to be in good condition.

Transformers

- If the goal is a Net Zero all-electric building, then the preliminary load calculations indicate that an increase in electrical service would be required as rated at 1000 amps (100% rated) at 120/208 volt, three phase, four wire.

New building electric service(s) should be provided via electric utility company pad mounted transformer(s) with primary electric service conduits in concrete duct bank(s) and secondary electric service cabling/conduits in concrete duct bank(s).

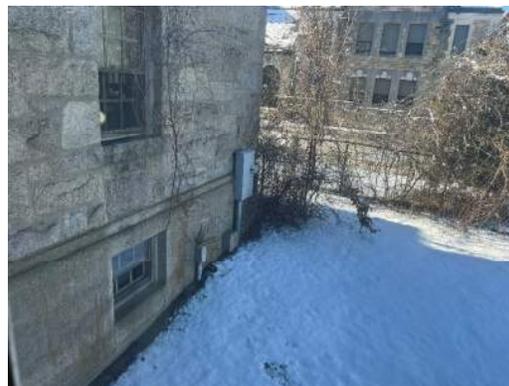
Utility Meter

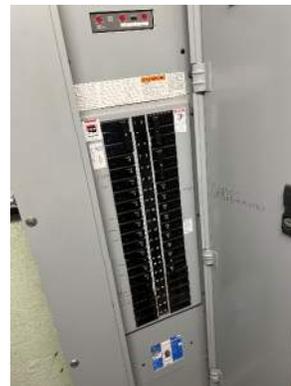
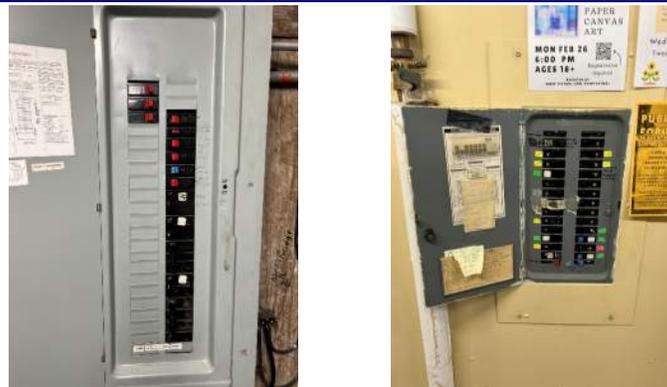
Panelboards

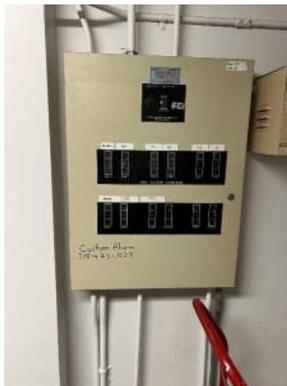
Fire Alarm System

- A new fire alarm system including voice evacuation should be provided to meet current Codes.

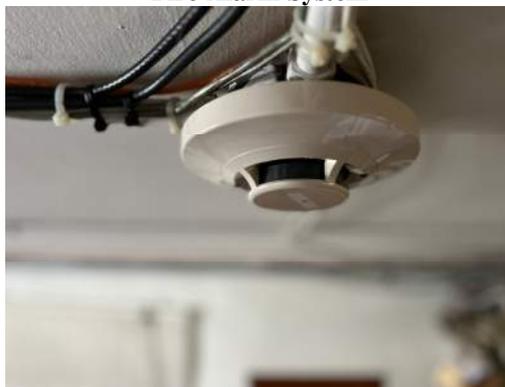
Smoke Detector

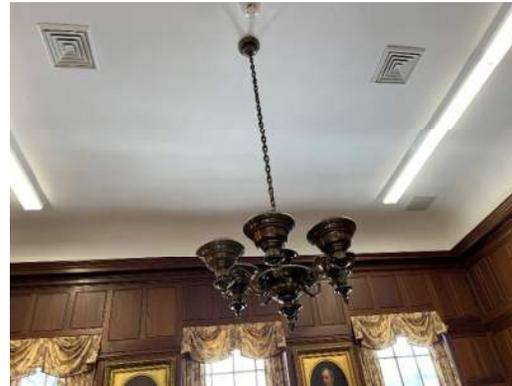
Lighting

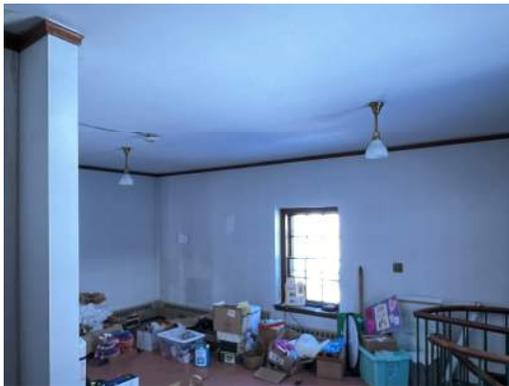
Lighting

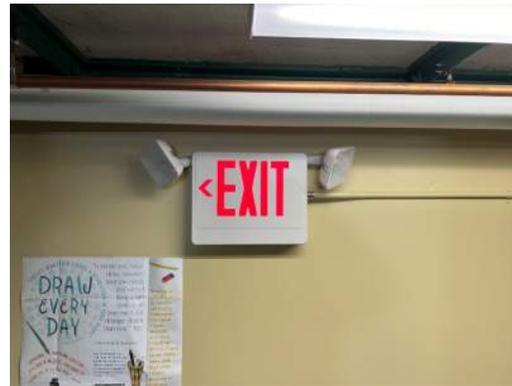
Emergency Lighting

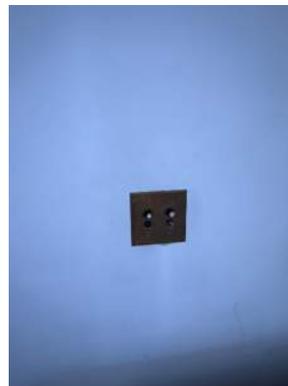
Switching

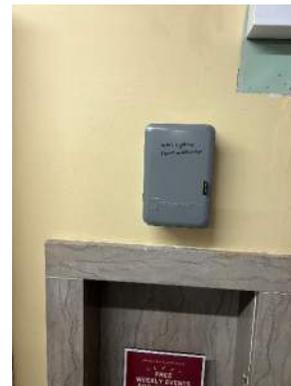
Exterior Lighting Control
